NORTHWIN LANDFILL 2025 ANNUAL OPERATIONS & MONITORING REPORT

PRJ24074

March 31st, 2026

Re: Northwin Landfill 2025 Annual Operations & Monitoring Report

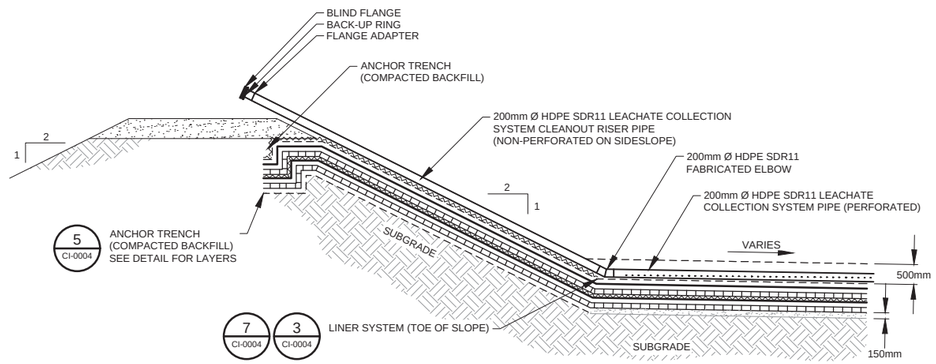
DETAIL 8 (CI-0003) — N.T.S. — LEAK DETECTION DETECTION PORT (TYP.) PROFILE

The leak detection ports were installed differently than designed by GHD. No depression was established beneath the leak detection port as shown in Appendix A. Without the depression, the leak detection pipe could not be buried in sand as originally designed. Instead, two layers of geocomposite were installed on top of the leak detection pipe to prevent the GCL layer from deflecting around the pipe and to ensure a hydraulic connection (Field Notes Aug 21 & 23). This change was approved by GHD.

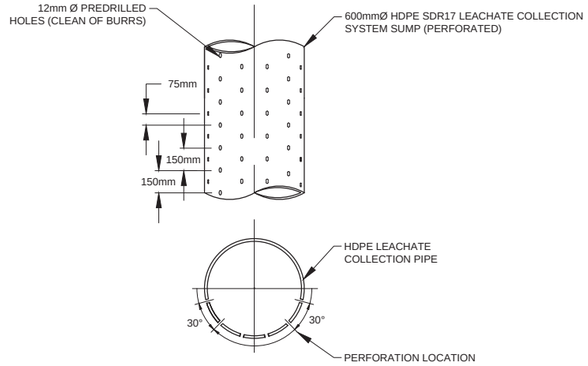
Title
DETAILS
LEACHATE LEAK
DETECTION SUMP

A field adjustment was made to the 300 mm HDPE leak detection system riser (see Appendix A). Adjustments from design included wrapping the perforated portion of the pipe in geo-composite and placing sandbags on the east side of the pipe to secure the pipe in place. Wrapping the pipe in geo-composite ensured there was hydraulic connectivity around the pipe. GHD witnessed the sand being placed in the leak detection portion of the sump and observed that the sump would function as intended with the modifications made. (Aug. 25 field notes)

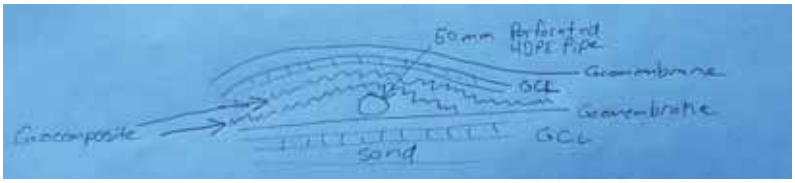
Construction notes on leak detection ports

-Leak detection monitoring ports were field fit by the Contractor (without the presence of the Engineer)
-3 m section of perforated pipe was placed on top of geomembrane, two layers of geocomposite were placed on top of pipe, see sketch below
-The two layers of gemeombrane on top of perforated pipe will prevent the upper GCL from deforming around the perforated pipe and ensure hydraulic connectivity in the inter-membrane will be acceptable.
-Without depression below leak detection port, small volumes flowing past the detection port will be difficult to detect
-Port will function acceptably for detecting larger flow volumes and leachate pooled on the geomembrane in the area of the ports

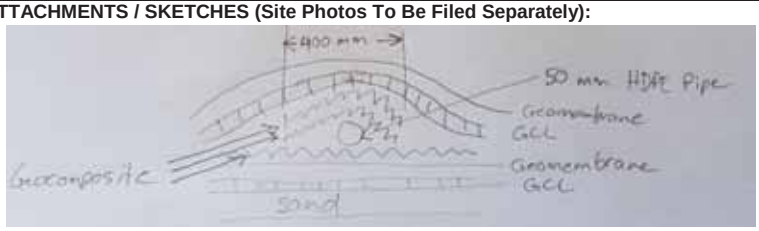
-Observed crew placing geocomposite on North Slope and North-East Corner
-Witnessed destructive test, DT-11, field sheer and peel and sent sample to lab
-Observed Field fit of leak detection port on North Slope nearest to the sump

Construction notes on leak detection port:
-Leak detection port was field fit with Engineer present
-50 mm HDPE pipe was run along geomembrane, 3 m perforated section was placed on Geocomposite (see sketch below)
- Two 40 cm wide strips of geocomposite were placed on top of perforated section and heat seamed to layer below
- Installation achieves hydraulic connectivity with the inter-membrane space and will prevent the upper GCL from deforming around perforated pipe
- Lack of depression where perforated pipe sits will make it difficult to detect small volumes of leachate flowing past leak detection port
-Port will function acceptably for detecting large volumes or leachate pooled on the geomembrane in the area

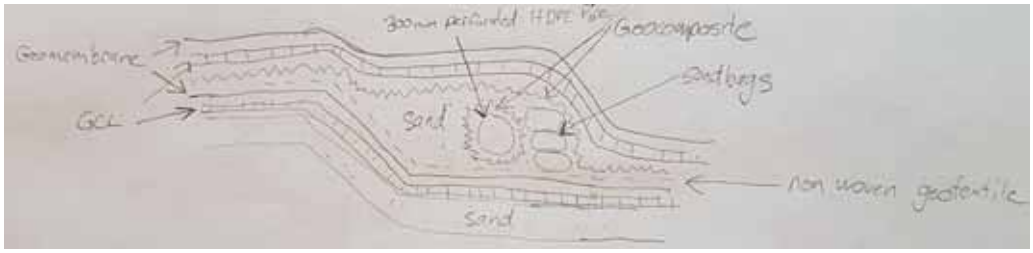
Leak detection pipe details:

-The following modifications from design were observed and approved in the field by the Engineer:
-Sandbags were placed on east side of perforated pipe to secure pipe in place
-300mm perforated HDPE pipe was wrapped in geocomposite to maintain hydraulic connectivity between pipe and sandbags
-Non-woven geotextile was installed above lower geomembrane layer
-See sketch of installation below

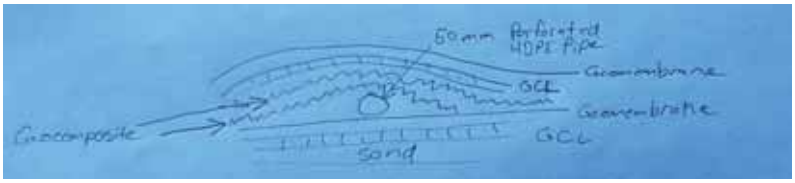
Construction notes on leak detection ports

-Leak detection monitoring ports were field fit by the Contractor (without the presence of the Engineer)
-3 m section of perforated pipe was placed on top of geomembrane, two layers of geocomposite were placed on top of pipe, see sketch below
-The two layers of gemeombrane on top of perforated pipe will prevent the upper GCL from deforming around the perforated pipe and ensure hydraulic connectivity in the inter-membrane will be acceptable.
-Without depression below leak detection port, small volumes flowing past the detection port will be difficult to detect
-Port will function acceptably for detecting larger flow volumes and leachate pooled on the geomembrane in the area of the ports

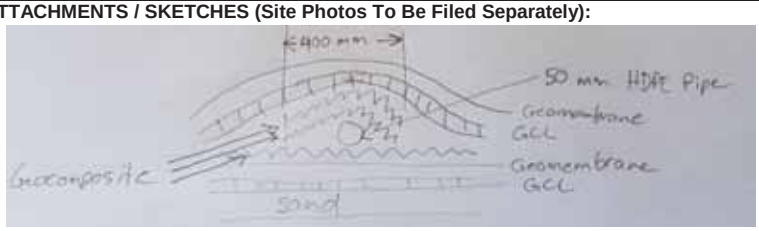
-Observed crew placing geocomposite on North Slope and North-East Corner
-Witnessed destructive test, DT-11, field sheer and peel and sent sample to lab
-Observed Field fit of leak detection port on North Slope nearest to the sump

Construction notes on leak detection port:
-Leak detection port was field fit with Engineer present
-50 mm HDPE pipe was run along geomembrane, 3 m perforated section was placed on Geocomposite (see sketch below)
- Two 40 cm wide strips of geocomposite were placed on top of perforated section and heat seamed to layer below
- Installation achieves hydraulic connectivity with the inter-membrane space and will prevent the upper GCL from deforming around perforated pipe
- Lack of depression where perforated pipe sits will make it difficult to detect small volumes of leachate flowing past leak detection port
-Port will function acceptably for detecting large volumes or leachate pooled on the geomembrane in the area

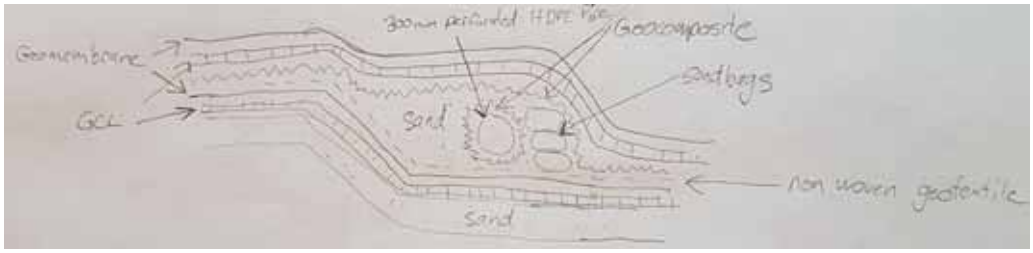
Leak detection pipe details:

-The following modifications from design were observed and approved in the field by the Engineer:
-Sandbags were placed on east side of perforated pipe to secure pipe in place
-300mm perforated HDPE pipe was wrapped in geocomposite to maintain hydraulic connectivity between pipe and sandbags
-Non-woven geotextile was installed above lower geomembrane layer
-See sketch of installation below
